Real Estate Inspection Report

Report Number: 0804211P

Sample Inspection Report For:
21 New York Ave. Ocean City, N.J. 08226

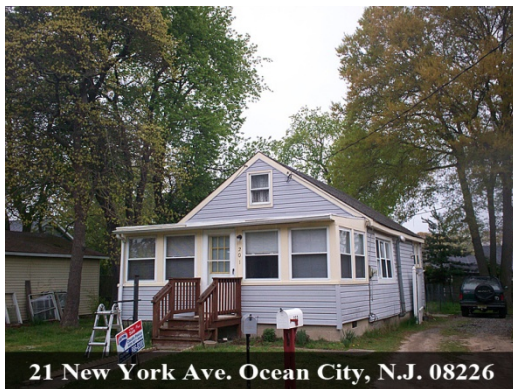
Photo 1

Please see **PHOTO 1** at the end of this report. Higher resolution photos have been attached to this document. Please click the "Paperclip" icon at the lower left to view.

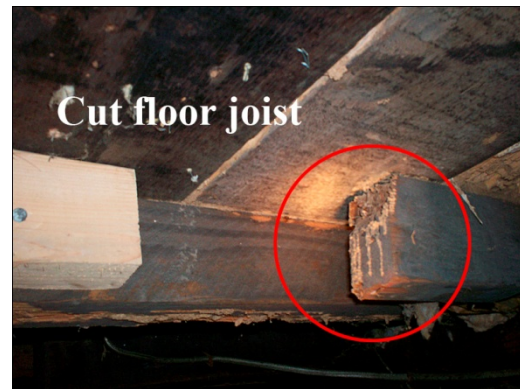
Photo 2

2. **Investigate Further:** Due to excessive framing damage noted in the crawlspace (cut framing members, rotting wood, damaged subflooring, uneven floors and walls out of plumb among others) I recommend a complete evaluation of the structure of the residence **Photo 2**.

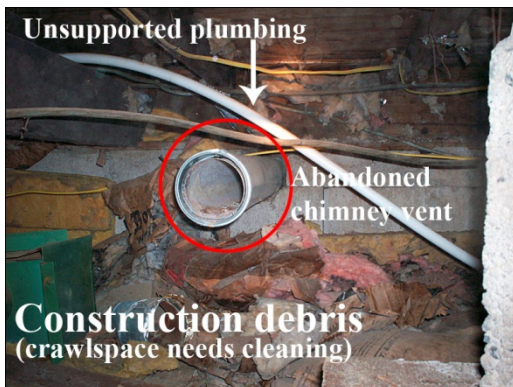
Photo 3

3. **Improve / Upgrade:** Debris (construction scraps, stored property, old form boards, trash) was observed in the crawlspace. This is not only unsafe but is conducive to infestation by vermin or wood-destroying insects. Recommendation: Removal of all debris. Once completely cleaned out the only thing remaining on the floor of the crawlspace should be a properly applied and intact vapor barrier **Photo 3**.

15. **Repair / Replace:** I found supply pipes that have not been properly suspended or secured with correct hangers or brackets. These must be corrected by installing appropriate hangers/brackets that are compatible with the materials used and are applied at proper intervals to ensure adequate support **Photo 3**.
16. **Improve / Upgrade:** Due to the location of the water heater I recommend that an insulating jacket be provided (cold attic space in winter).
17. **Comments:** The temperature pressure relief valve on the water heater was checked for proper installation and no defects were noted.

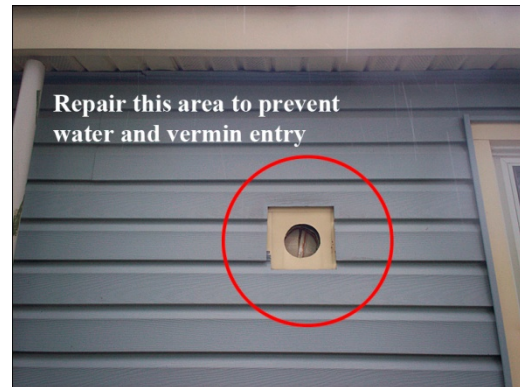
Photo 4

7. **Repair / Replace:** The siding is damaged at the left rear of the residence and needs to be repaired by a competent carpenter to ensure that the exterior envelope of the home remains weather tight **Photo 4**.

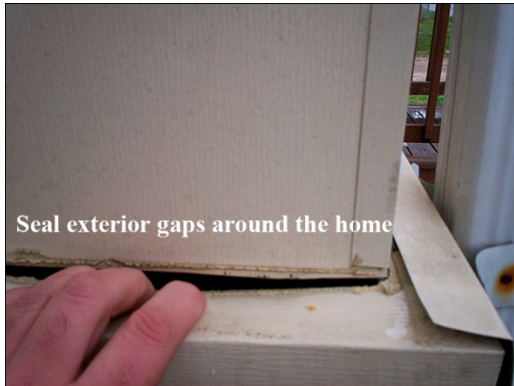
Photo 5

8. **Repair / Replace:** Gaps between dissimilar exterior components should be caulked and painted in order to prevent moisture infiltration into the structure **Photo 5**.

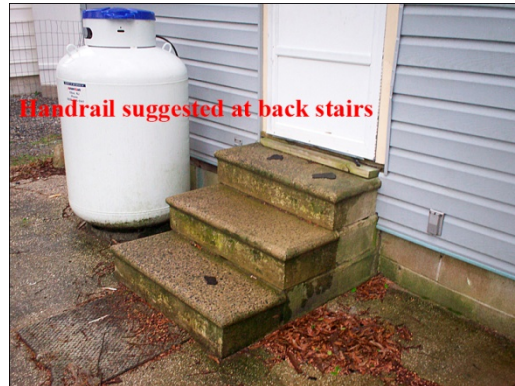
Photo 6

6. **Safety Issue:** The rear outside stairs doesn't have a railing or handrail. Any stairs with 3 or more steps or decks and landings that are higher than 30 inches above grade should have handrails and perimeter railings. I recommend immediate correction by a competent carpenter **Photo 6**.

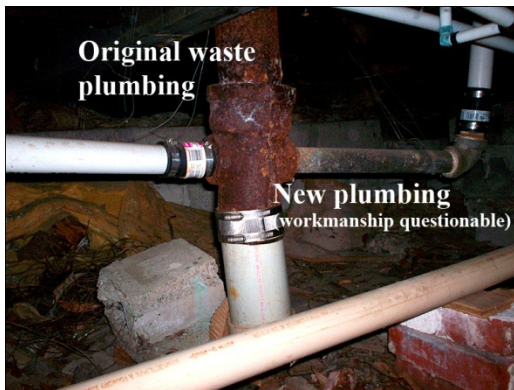
Photo 7

The drain/waste plumbing is a combination of schedule 40 ABS plastic, PVC DWV plastic and cast iron pipe (workmanship questionable **Photo 7**). Vent plumbing is PVC DWV plastic pipe.

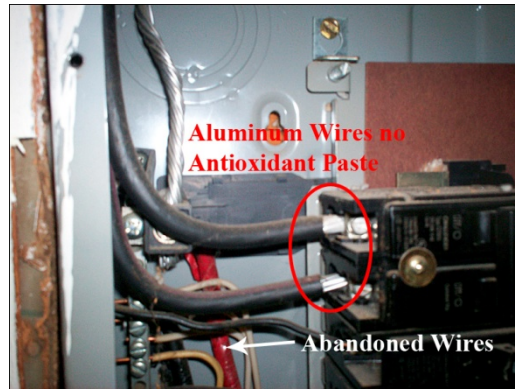
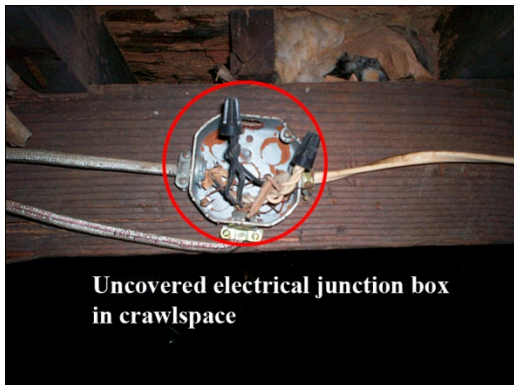
Photo 8

22. **Investigate Further:** Due to several deficiencies noted in the electrical system (abandon wires, open junction boxes, lack of anti-oxidant paste, ungrounded receptacles and possible over fusing) I recommend a complete evaluation of the electrical system by a licensed electrician **Photos 8&9**.

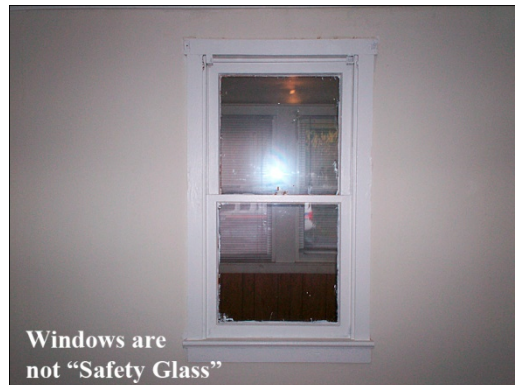
Photo 10

24. **Repair / Replace:** Several issues were noted with the windows in the home (inoperative in the sunroom, broken in the front bedroom and flooded in the bathroom). Repairs will be necessary. **Also**, the windows in the home that do not contain safety glass should be replaced (front bedroom for example) **Photo 10**.
